# Contaminated Mexican Steel Incident

Importation of Steel Into the United States That Had Been  
Inadvertently Contaminated With Cobalt-60 as a Result of  
Scrapping of a Teletherapy Unit

**U.S. Nuclear Regulatory  
Commission**

Office of Inspection and Enforcement

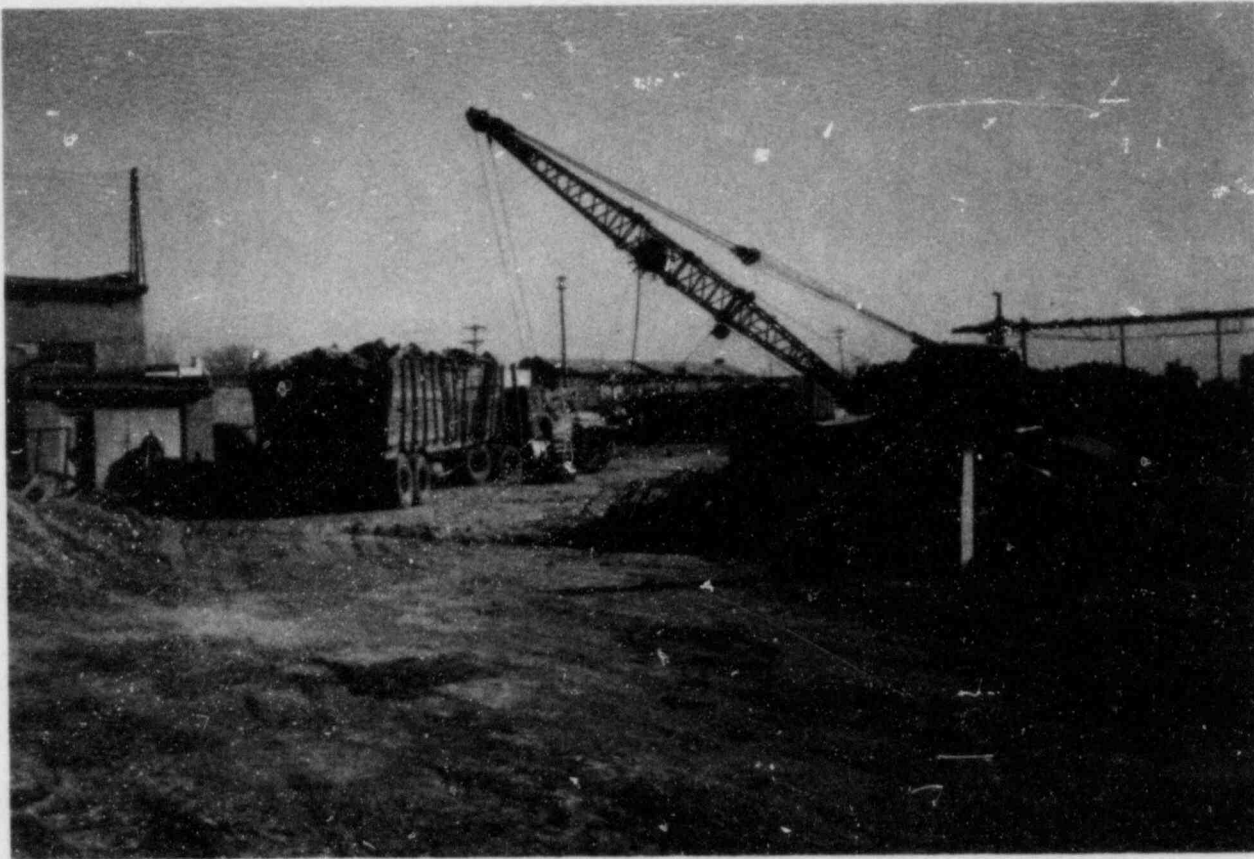
Figure 1.1 Yonke Fenix scrap yard showing loading of scrap on truck for transport to a foundry customer

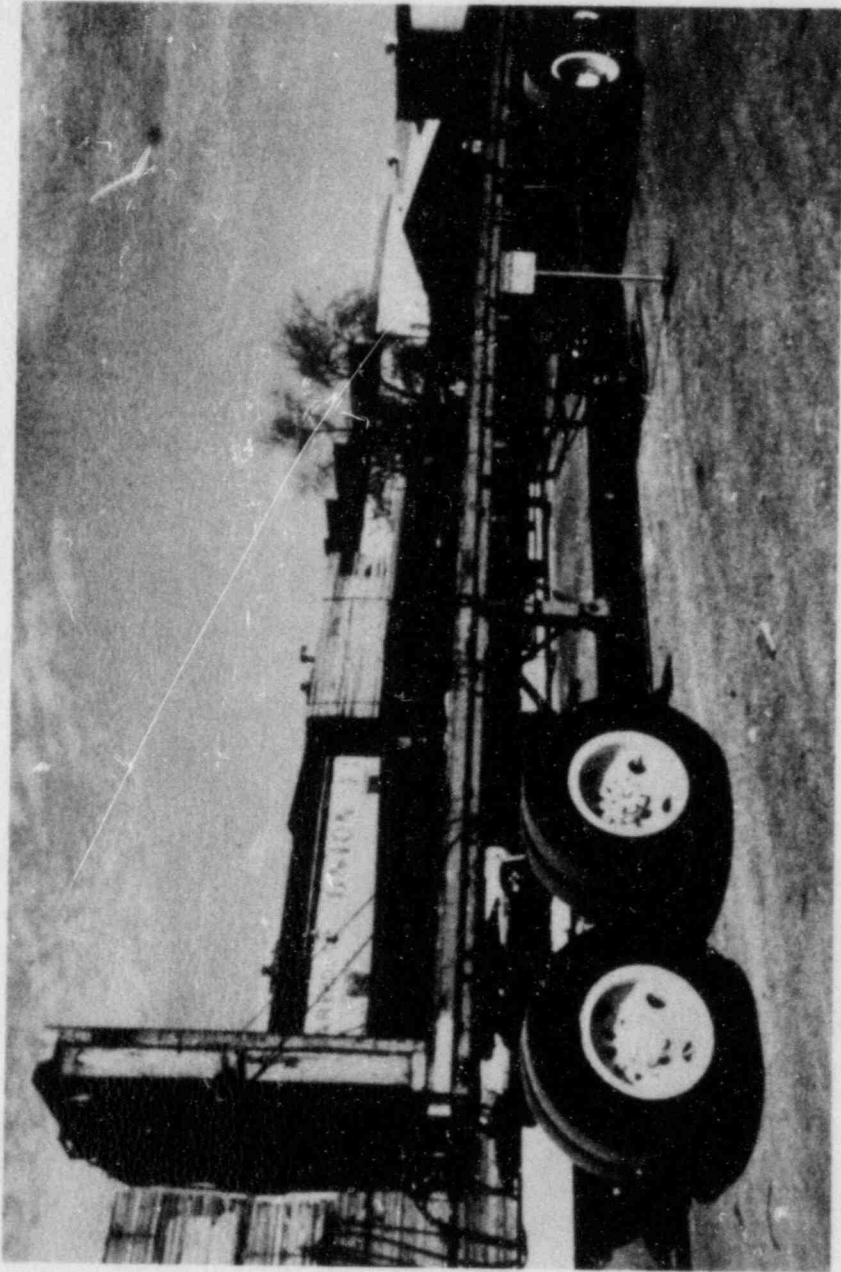
Figure 2.1 Truckload of steel rebar detained at El Paso border crossing

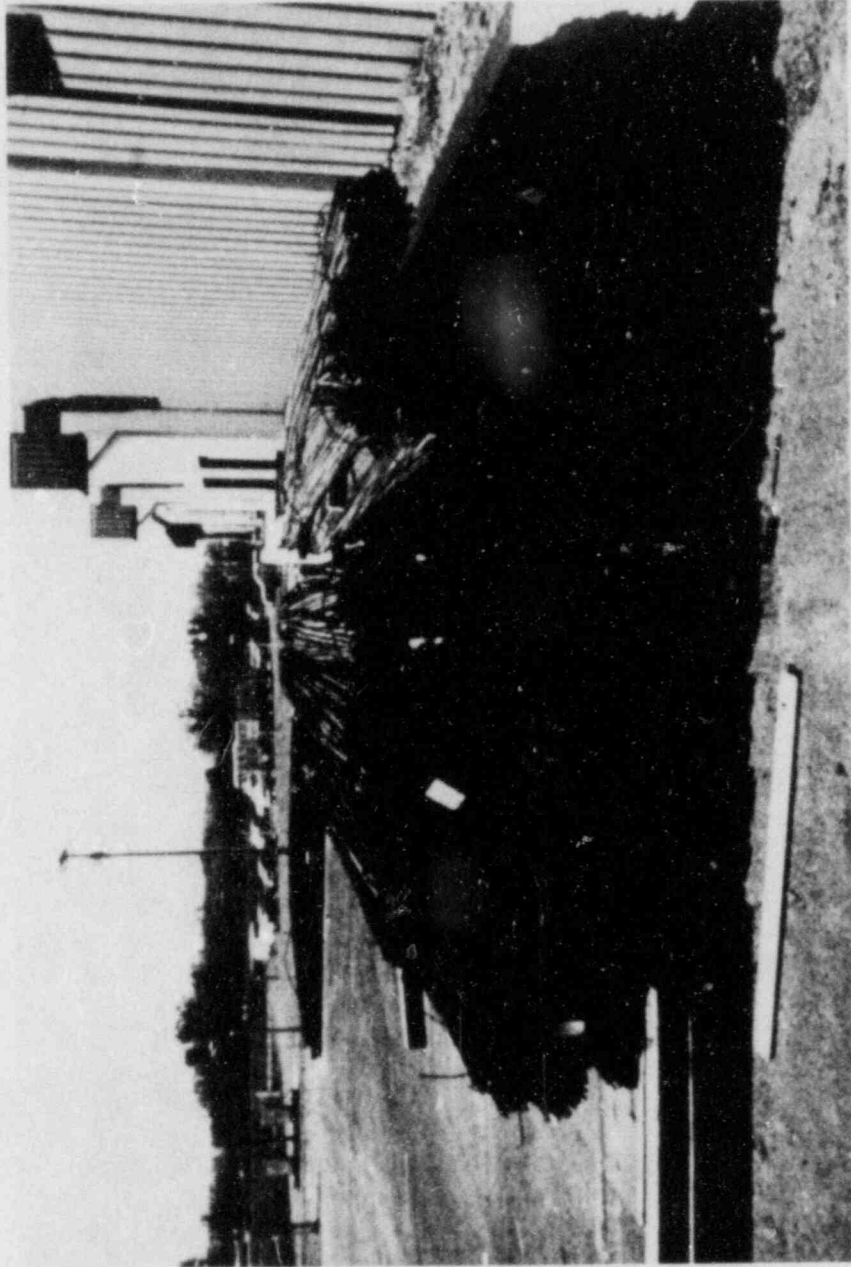
Figure 2.2 Rebar quarantined in Arizona

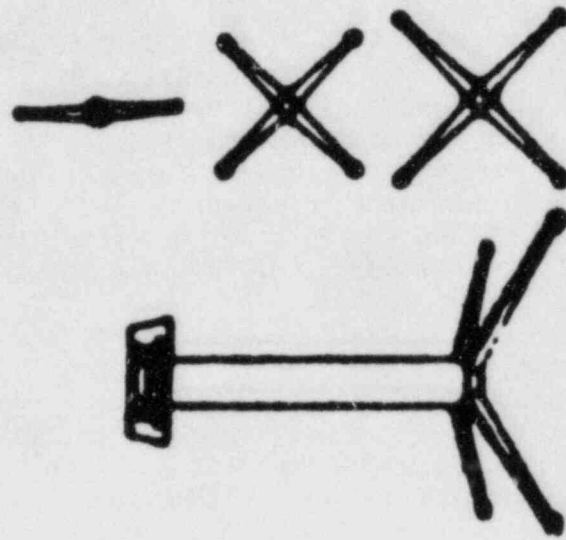
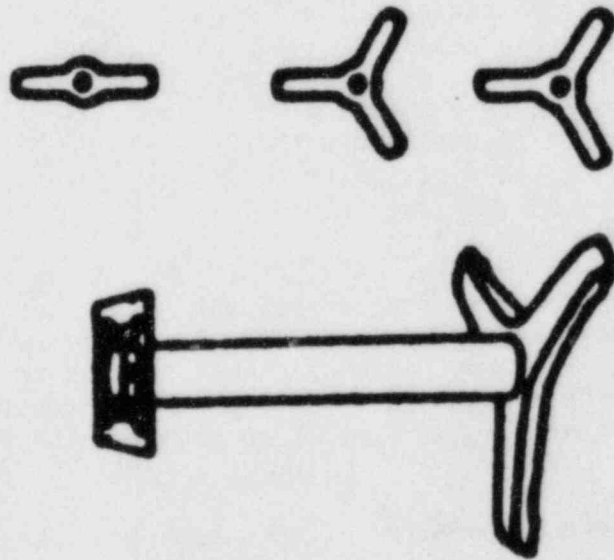
Figure 2.3 Cast iron table bases

The surveys also found that the cobalt contamination in the iron is not uniform and the radiation levels vary on different parts of the same casting.

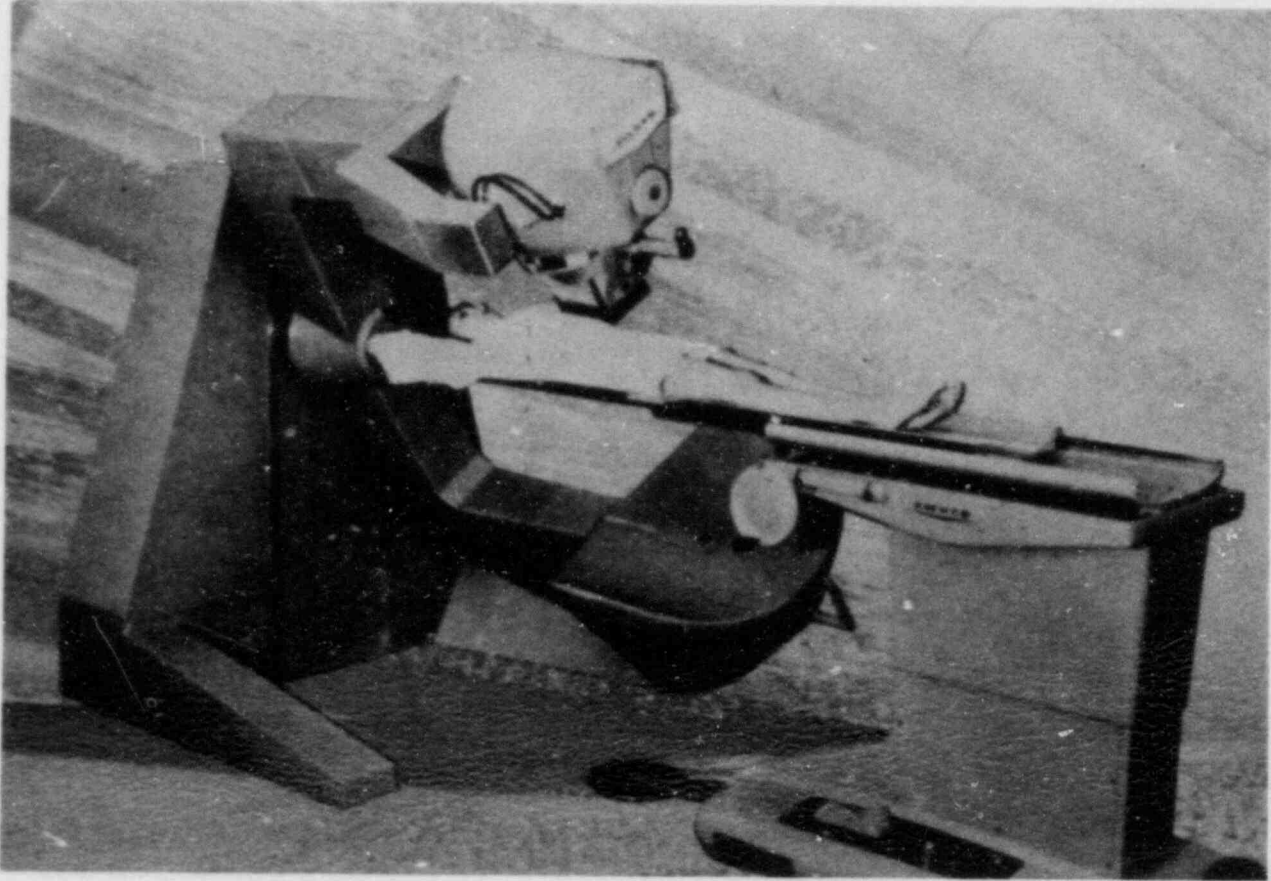
\* During the course of the investigation to identify the source, Advance Medical Systems indicated that in 1982, the Picker C-3000 unit had been declared obsolete because of an apparent structural defect in the "C" arm mechanism. Because structural failure of the "C" arm, while the machine was in operation, could have resulted in the arm collapsing on a patient causing injury or death, the company notified owners of the C-3000 unit and recommended that they be scrapped. In addition, the company informed owners that no new sources would be installed in these units unless the owner legally released the company of responsibility for structural failure (see Appendix D).

Figure 3.1 Picker C-3000 (75cm SAD) cobalt therapy unit

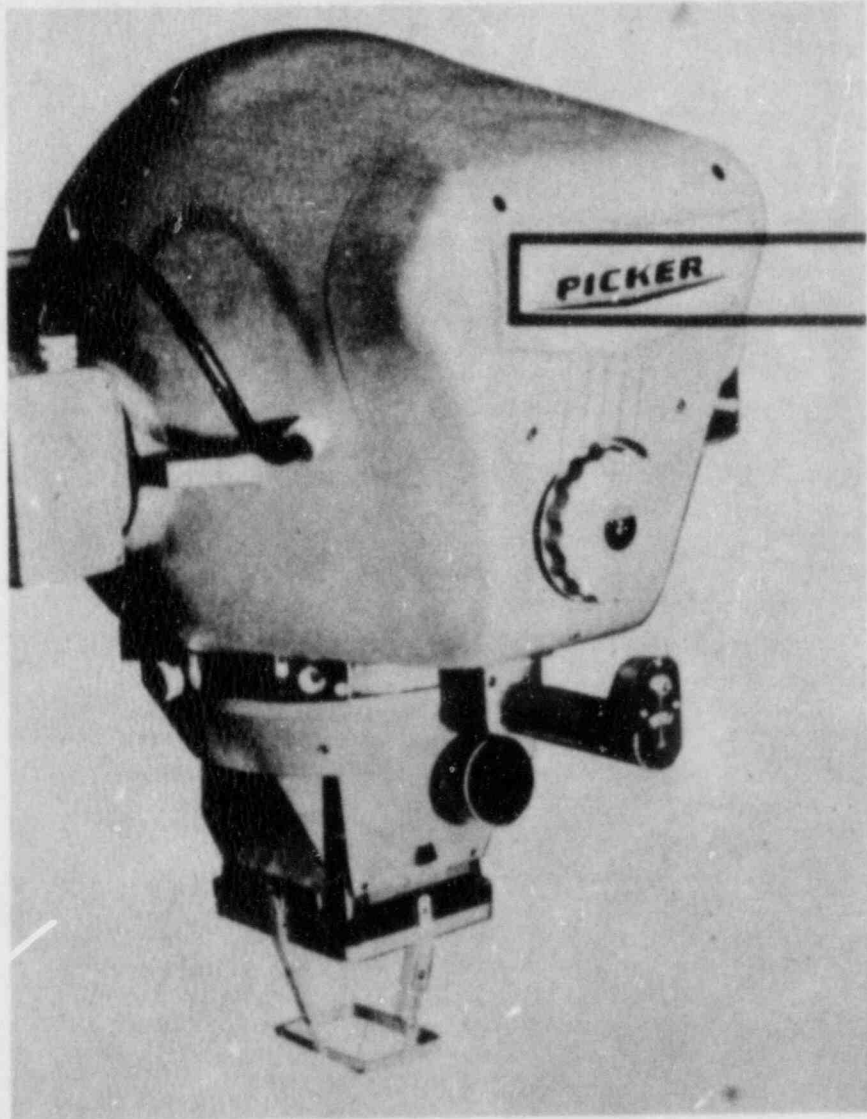
Figure 3.2 Picker C-3000 source head

The stainless steel, doubly encapsulated source capsule, located in the head of the teletherapy unit, measured about 2 cm in diameter and contained about 6,000 cylindrical cobalt metal pieces (pellets) about 1 mm by 1 mm. At the time of the incident each pellet contained about 0.07 curie of Co-60 and had an exposure rate of about 25 roentgens per hour at 5 cm (see Figures 3.2 and 3.3).

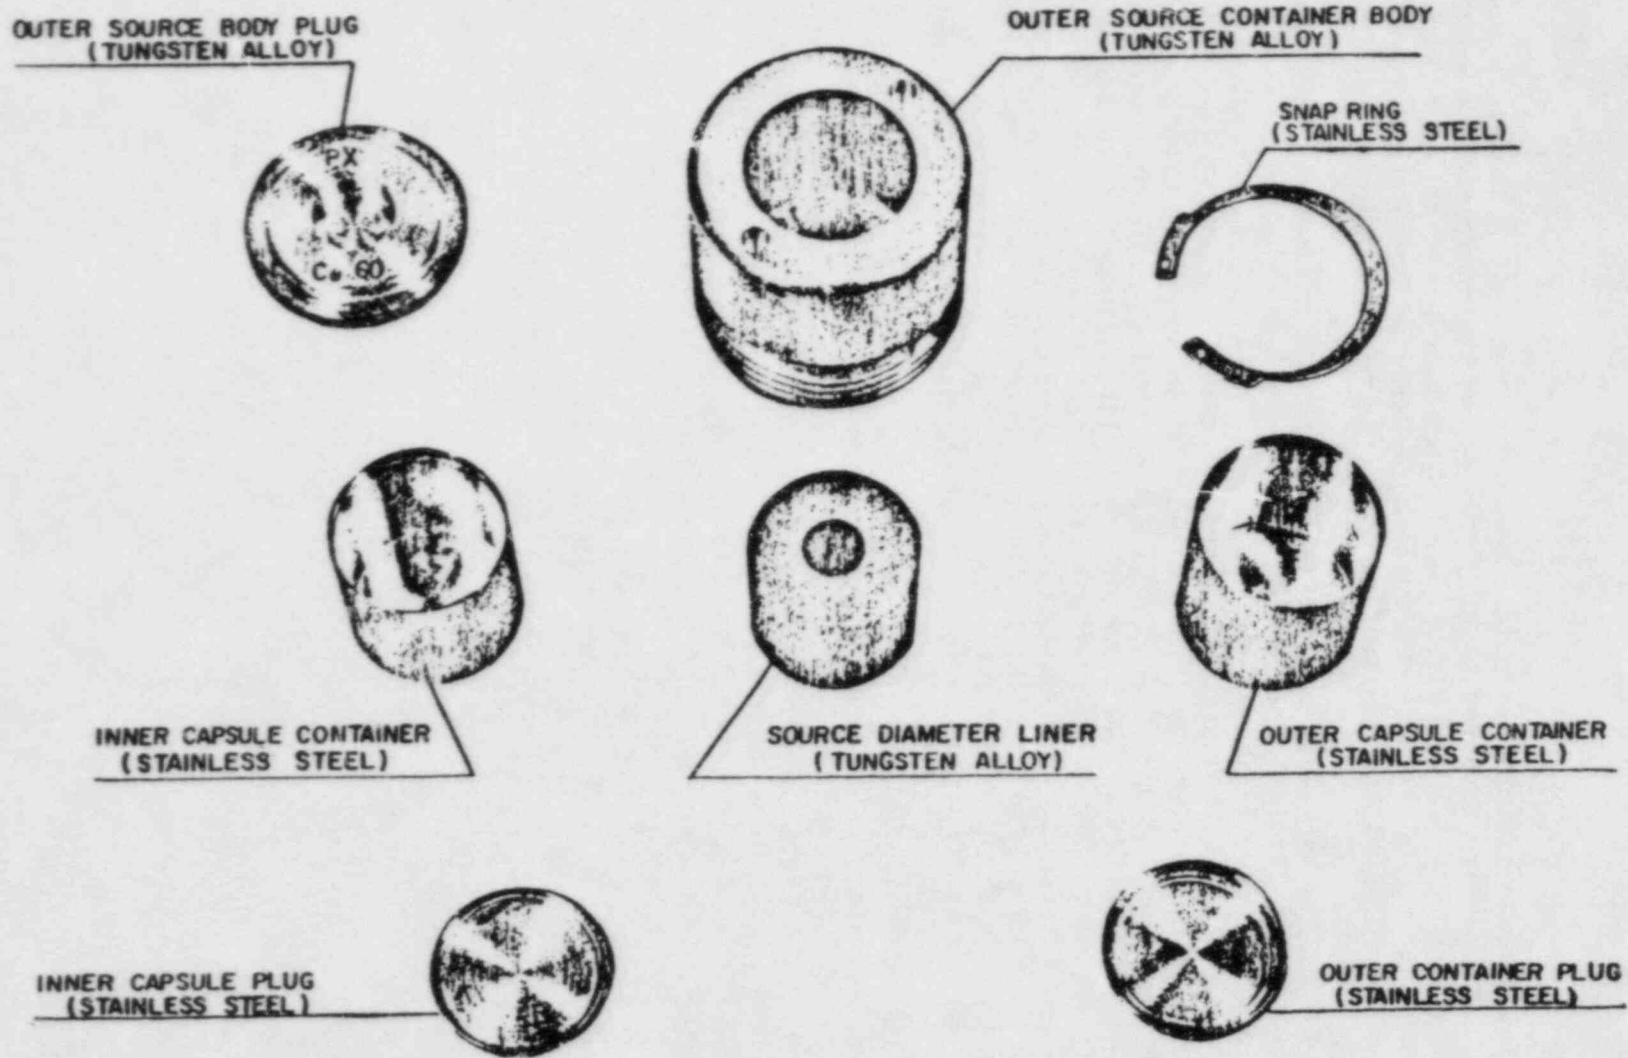
Figure 3.3 Source capsule components

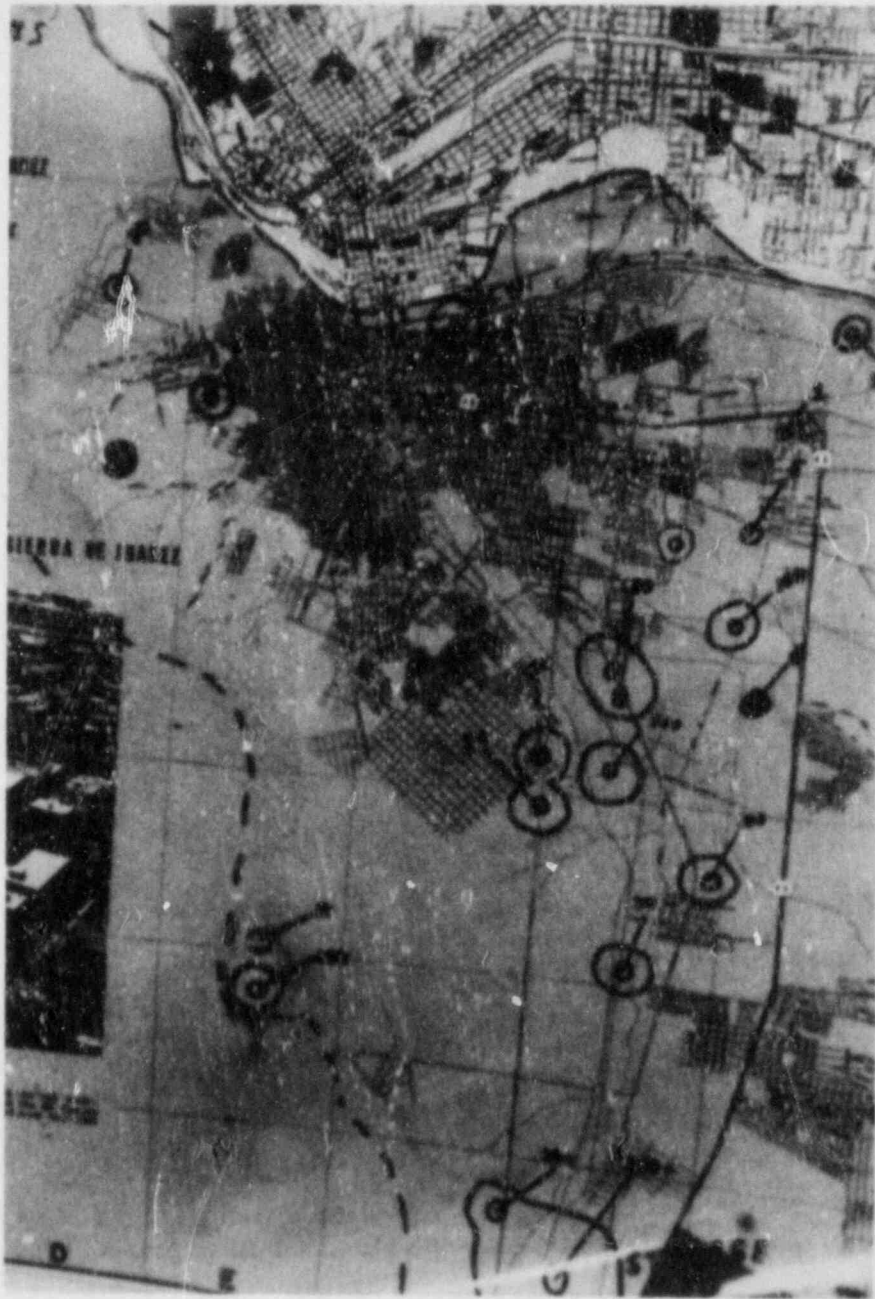
- (6) From March 19 through March 25, 1984, AMS flights were conducted over Juarez, Chihuahua, and the Juarez-Chihuahua corridor of Mexico. Contamination was found in several previously unknown locations. This survey detected 21

locations where Co-60 was present in the Juarez-Chihuahua area (see Figure 9.1). Cleanup of these spots was performed by Mexican decontamination teams.

Figure 9.1 AMS map showing contaminated areas in Juarez

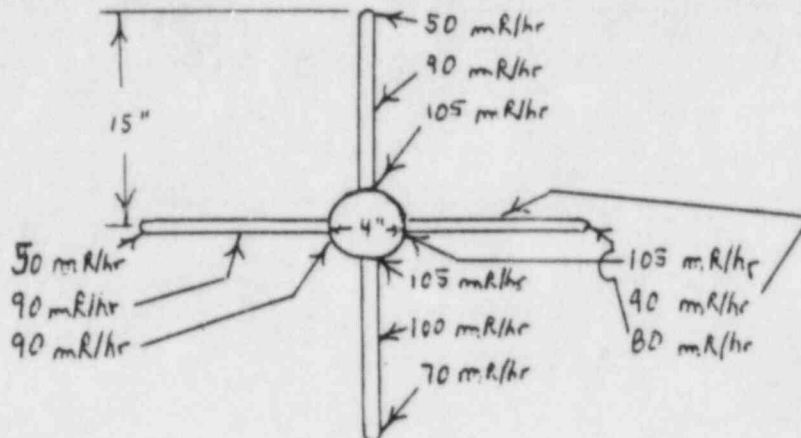
Table II: Approximate Radiation Profile for Table No. 3

A. Levels taken with Eberline PIC-6A at contact with table legs:

NOTE: Radiation all seemed to be in legs since the levels measured tapered off dramatically as went up column and around spider.
